Conklin Company Inc. TECHNICAL BULLETIN

B-01-05-4

Metal Building Thermal Bridging and Condensation

Considerations When Coating A Metal Roof

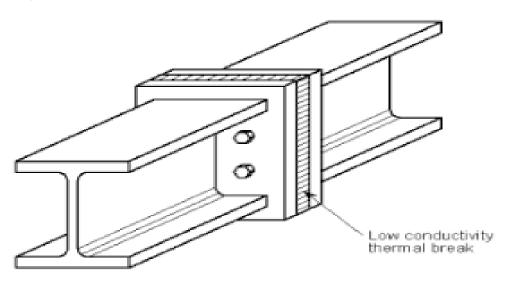
Figure #5

A **thermal break** or **thermal** barrier is an element of low **thermal** conductivity placed in an assembly to reduce or prevent the flow of **thermal** energy between conductive materials. (See figure #5)

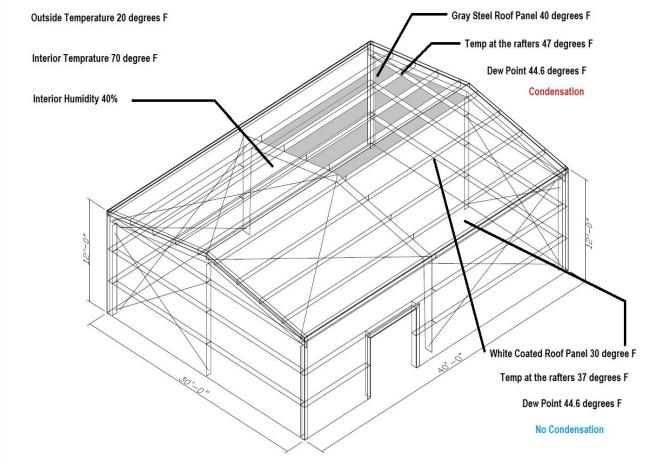
Each component of a metal building can contribute to thermal conduction and interior ambient temperature changes as well as temperature changes on the exterior of the building. One example of this phenomenon is when the roof panels are unpainted steel and they are coated with a highly reflective roof coating, in many cases this can cause a condensation issue through thermal conductivity. The dark panels will have more solar gain than a white coated panel and that means once coated, these panels will have a lower temperature. Depending on the interior temperature, humidity level, type of insulation and the climate zone, once a dark roof is converted to a light highly reflective roof, the thermal conductivity will change and condensation may be an issue. (See figure #6)

Figure #6 shows a scenario where the building is heated, the insulation is lose or missing in one area which allows the warm heated air to contact the colder thermal bridge (rafter and roof panel) and cause a condensation situation.

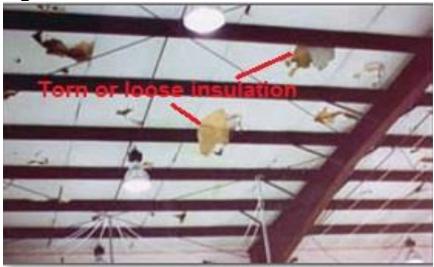
Figure #7

Loose, torn or missing insulation is one of the most common causes for thermal bridging. Another reason for this issue comes from the original design of the building. (See figure #7)
