Conklin Company Inc. TECHNICAL BULLETIN

B-01-05-4

Metal Building Thermal Bridging and Condensation

Considerations When Coating A Metal Roof

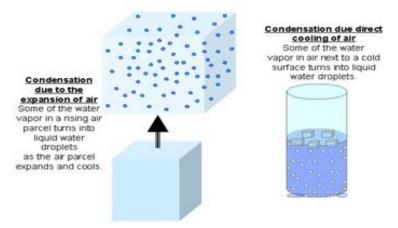
Figure #1

- 1) Water that collects as droplets on a cold surface when humid air is in contact with it. (*synonyms:* moisture, water droplets, steam) "windows misty with condensation"
- The conversion of a vapor or gas to a liquid. (synonyms: precipitation, liquefaction, deliquescence.) "the condensation of the vapor" (See figure #1)

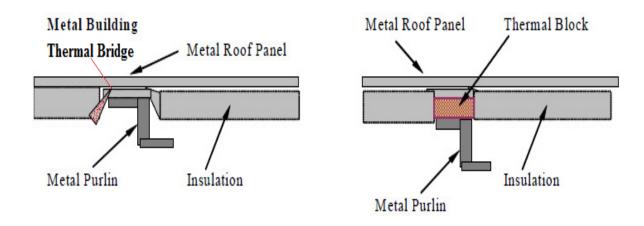
Figure #2

A **thermal bridge**, also called a cold **bridge** or heat **bridge**, is an area or component of an object which has higher **thermal** conductivity than the surrounding materials, creating a path of least resistance for heat transfer. **Thermal** bridges result in an overall reduction in **thermal** resistance of the object. (See figure #2 - #4)
